## Learning from Earthquakes

### The Chamoli, India, Earthquake of March 29, 1999

#### Introduction

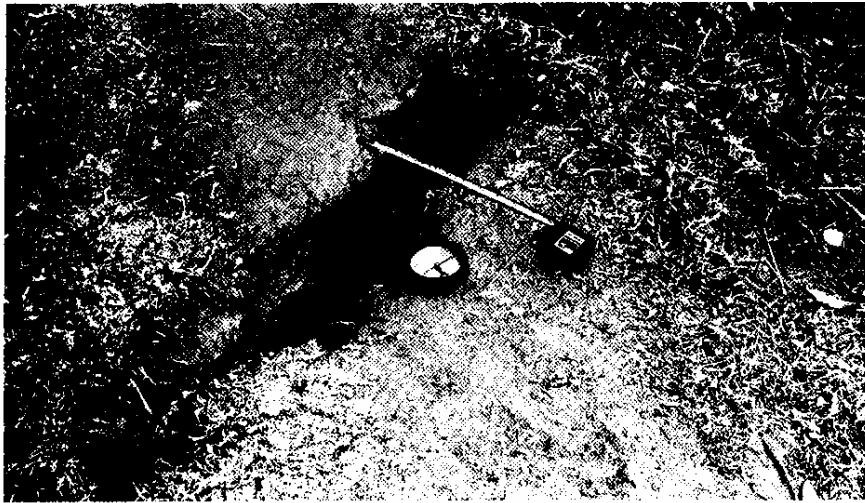
Figure 3: Ground fissure at Telcom Hill near Gopeshwar.

The Chamoli earthquake was accompanied by severe ground deformations. Fissures, landslides and changes in the groundwater flow were reported from several locations. Well-developed ground cracks, trending roughly in the east-west direction and showing lateral movement of up to about 12 cm, were observed in Gopeshwar, Chamoli and Bairagna. Attempts were made to trench across some of these ground fissures at Telecom Hill, Gopeshwar (Figure 3), but none of the trenches could be extended downward more than a meter because of debris and boulders. In one of these trenches, a poorly defined thrust plane was detected. Orientation of these discontinuous ground fissures conforms to the strike

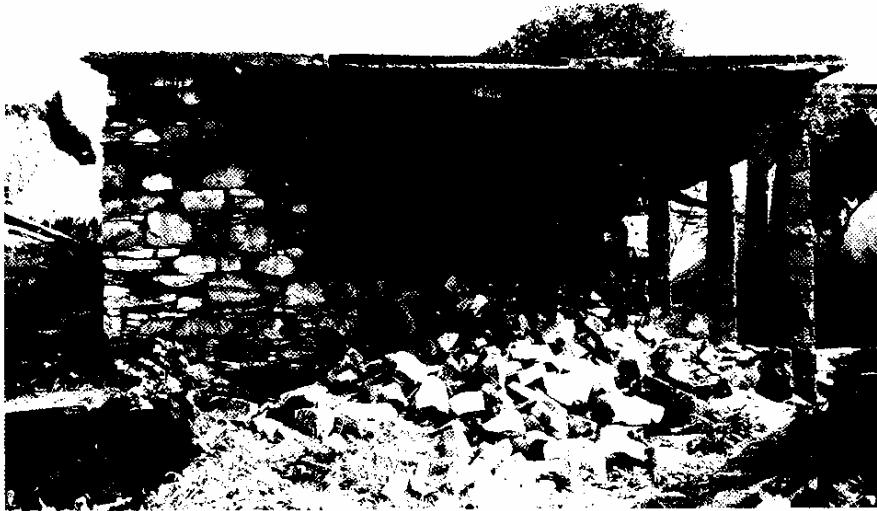
**Figure 6:** Partial collapse in a random rubble stone masonry building. Note that the front portion has RC beam supported on concrete block columns, and the roof consists of an RC slab.

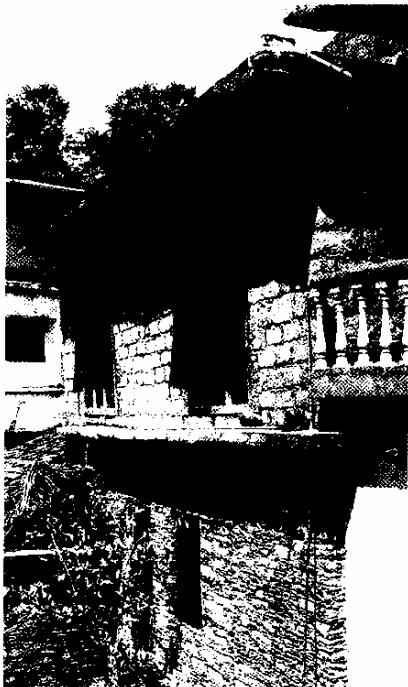
**Figure 7:** Two-story house at Pipalkoti with no damage. Ground story in slate wafer masonry, upper story added later in concrete block masonry. Both stories have an RC lintel band.

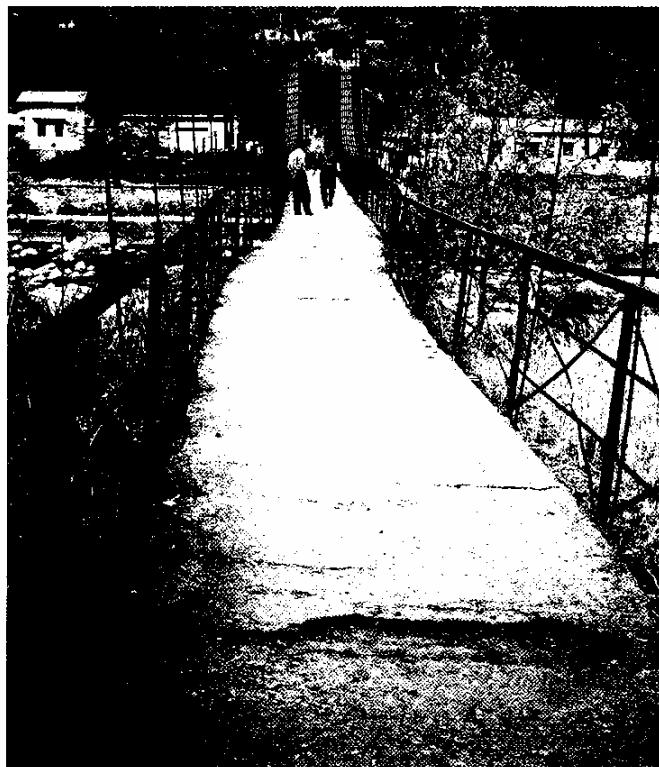
The area has numerous pedestrian bridges across the rivers, some of which are suspension bridges with spans ranging from 15 m to 60 m. Lateral buckling of the bridge deck was observed at one of the pedestrian suspension bridges located near Bairagna (Figure 10). The cables were found to have loosened, possibly due to the shifting of the anchor block at one end where there was slope instability.

**Figure 10:**  
Lateral buckling  
of the deck of a  
suspension  
bridge at  
Bairagna.
