The September 29, 1993, M6.4 Killari, Maharashtra, Earthquake in Central India

Sudhir K. Jain (EERI 1987), C.V.R. Murty, Navin Chandak (all three of the Indian Institute of Technology in Kanpur; sponsored by EERI), Leonardo Seeber (of the Lamont-Doherty Geological Observatory; sponsored by NCEERI), and N.K. Jain (of the Joint Assistance Center in Delhi) joined in a team to investigate the effects of the Killari earthquake. This report is the result of their cooperative effort. The publication and distribution of this report is supported by National Science Foundation grant #BCS-9215158 as part of the EERI Learning From Earthquakes project.

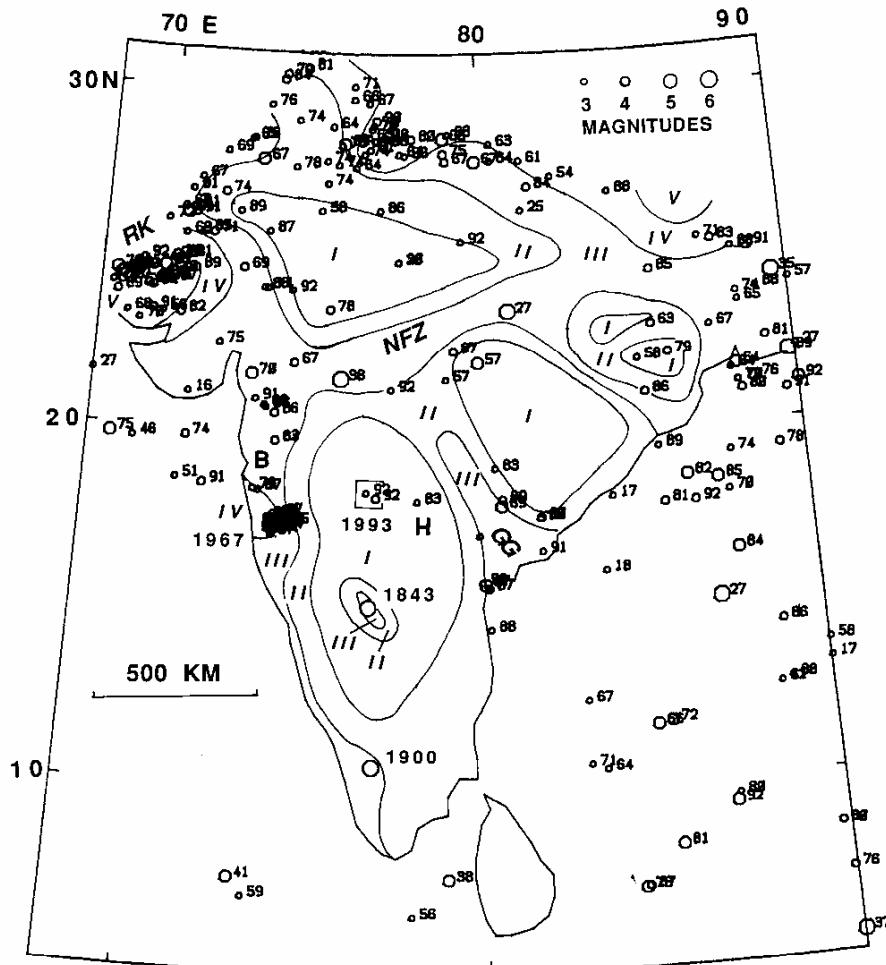
Figure 1 - Seismicity (ISC catalog, 1901-1992; epicenters indicated by a circle and the last two digits of the year; epicenters along the Himalayan and Baluchistan Arcs omitted to avoid clutter) and earthquake hazard zonation in five categories (I to V is lowest to highest, respectively, Geological Survey of India, 1992). The 1993 Killari epicentral area is indicated by a box; the two epicenters within this area are the largest representatives of the very active precursory swarm felt in Killari in 1992. Large and destructive earthquakes near Bellary, 1843, and near Coimbatore, 1900, are also plotted (years indicated in full). 1967 is the year of the largest earthquake from the very active reservoir-induced source zone near Koyna. RK = 1819 Rann of Kuch earthquake; NFZ = Narabada fault zone; GG = Godavari Graben; B = Bombay; H = Hyderabad.

arcs, the topographic expression of a collisional plate boundary that marks the northern limit of the shield. Yet, intracratonic seismicity in India is well represented, both in number and in size (Figure 1). The 1819 Rann of Kuch earthquake (RK in Figure 1) is associated with a surface rupture about 100 km long and a scarp up to 10 m high. It permanently altered the shape of the land surface over a very large area and was felt throughout northern India. Other intracratonic Indian earthquakes associated with loss of human life are: Bellary, Karnataka, 1843; Coimbatore, Tamil, 1900; Anjar, Gujarat, 1956 (5.5, 115 killed); Koyna, Maharashtra, 1967 (6.4, 200 killed); and Bharuch, Gujarat, 1970 (5.4, 30 killed).

because the relatively short historic period is likely to give an incomplete picture of the possible earthquake sources. The hazard zonation in Figure 1 conform to this state-of-the-art approach and is based on both seismicity and geology. For example, the earthquakes in 1843 and 1900 as well as the Narabada fault zone (NFZ) and the Godavari Graben (GG) clearly affect the perceived distribution of hazard. Should we then be surprised that the 1993 Killari epicenter is in an area with the lowest perceived hazard? Probably not, since many similar intracratonic earthquake sequences worldwide have occurred in areas with little prior known seismicity and without previously recognized seismogenic structures. Thus, the 1993 Killari earthquake sequence is a dramatic reminder that criteria currently used to map hazards in intracratonic areas may not be satisfactory.

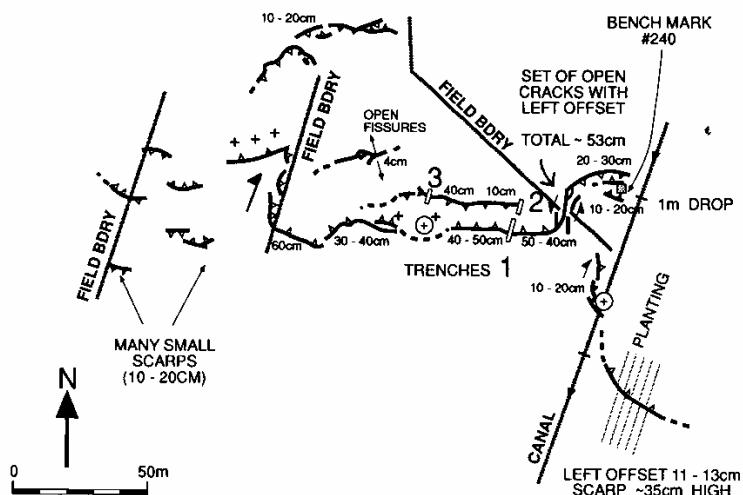
Figure 2 - Portion of the surface rupture associated with the 1993 Killari earthquake. This rupture was mapped discontinuously in an east-west zone over a distance of about 1 km. Barbs indicate the uplifted side of the scarps; the approximate height of the scarps is also indicated. Plus signs indicate uplifted area, circled when localized. Note that a "transform" fault connects a south-facing scarp in the center of the map with a north-facing scarp on the right. This "transform" offsets a field boundary by 53 cm left laterally, which is a minimum measure of the shortening. The strike of this and other "transforms" in this map is north-northeast, the inferred direction of shortening.

tinuous scarps were discernible along a west-northwest zone about 1 km long and starting 1.5 km west of the village of Killari. Where best expressed, the surface trace of the rupture is very complex; it is multibranched, double vergent, and discontinuous (Figure 2). Most scarps trend approximately east-west; a few north-northeast trending scarps show evidence of predominant horizontal components of motion. The sense of movement is in each case consistent with their interpretation as "transform" faults connecting different branches of the system.

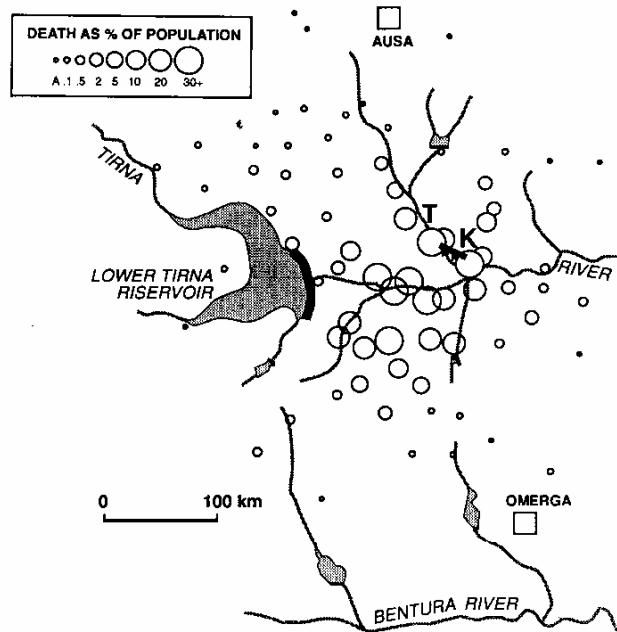
Figure 3 - Number of officially recorded fatalities as percentage of population in villages in the epicentral area. A surface rupture was mapped near the village of Killari (K) and inferred to extend at least to the village of Talni (T). Surface deformation features reflect a reverse fault dipping to the southwest. Note that the zone of highest relative fatalities (20-30 percent) is centered southwest of the trace of the thrust, above the inferred rupture. Note also that this rupture is centered about 10 km from the Lower Tirna Dam.

Figure 3 shows fatalities relative to the total population in each village. These gruesome statistics are quite effective in delineating the mesoseismal area. In an area about 10x10 km centered on the Tirna River, 20-30 percent of the people were killed. Outside this area relative casualties decrease rapidly. This mesoseismal area probably corresponds spatially to the main shock rupture; the surface trace of the rupture is along the northern limit of this area.

voir (Figure 3). The maximum water depth is about 20 m, which is at the low end of the range of depths of reservoirs where induced seismicity has been documented. The reservoir level was low at the time of the main shock, which is consistent with the expected negative effect of the loading by the reservoir on an underlying thrust fault. The $M=6.4$ 1967 Koyna earthquake and a related long-term swarm is one of the best known cases of seismicity triggered by a reservoir. Several other recent earthquakes in peninsular India appear to be located close to reservoirs. Whether the Killari earthquake was triggered by the Lower Tirna Reservoir is not known, but it can not be ruled out at this time. In any case, induced seismicity in cratonic India may be more prevalent than generally recognized and the distribution of reservoirs may be relevant to earthquake hazard no less than the distribution of historic seismicity.

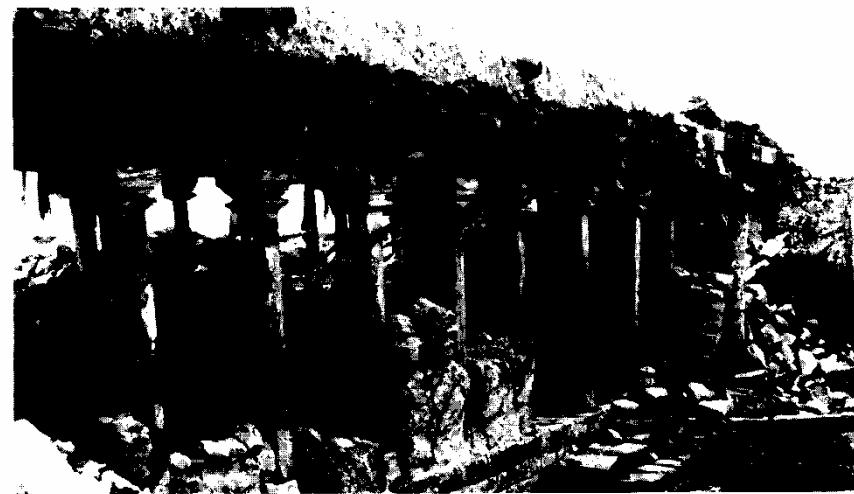
A number of dwellings in the affected villages had timber columns connected together with transverse and longitudinal beams. The roof planks in these houses were supported by the timber beams and columns rather than the rubble masonry walls. When securely anchored to the floor and to the roof beams, the posts tended to hold up the roof and prevent the inward collapse of the walls, thereby saving the inhabitants.

Figure 5 - In some buildings, the traditional heavy clay roof was supported on a frame of wood posts and beams. In most cases, the timber columns continued to hold the roof together while the walls collapsed, generally outwards from the timber frame, saving the lives of many occupants.

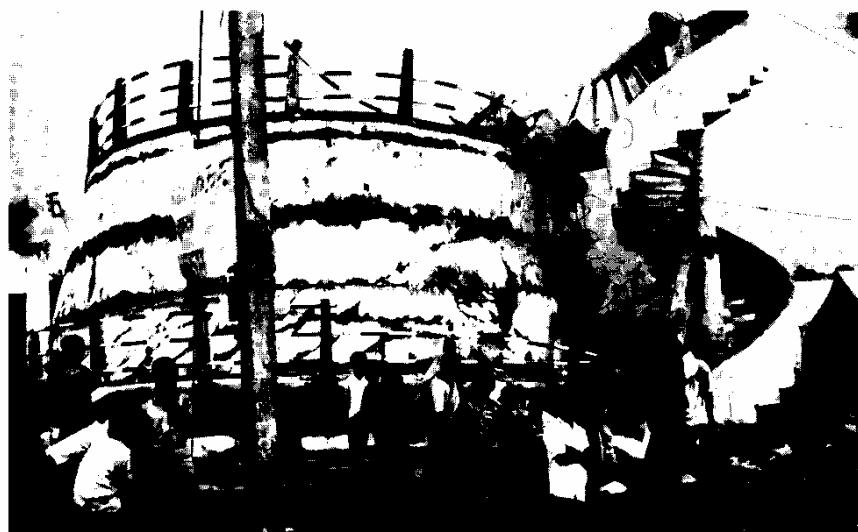
Figure 7 - While most elevated water tanks performed quite well, this tank at Kautha collapsed straight down onto its crumpled supports. Circumferential displacement of about 0.5 m suggests that rotational vibration led to its collapse.

For water supply, most of the villages had an elevated water tank consisting of a reinforced concrete container supported on a concrete moment-resisting frame about 10 m high, a standard design of the Public Health Engineering Department. Tank capacities ranged from 40 kl to 200 kl. Most of these tanks survived the earthquake with little or no damage. The one tank that suffered a complete collapse came straight down, burying the remains of the six supporting columns directly under the bottom dome of the tank. That, and evidence of a circumferential displacement of about 0.5 m, suggest torsional vibrations were the primary cause of the damage.

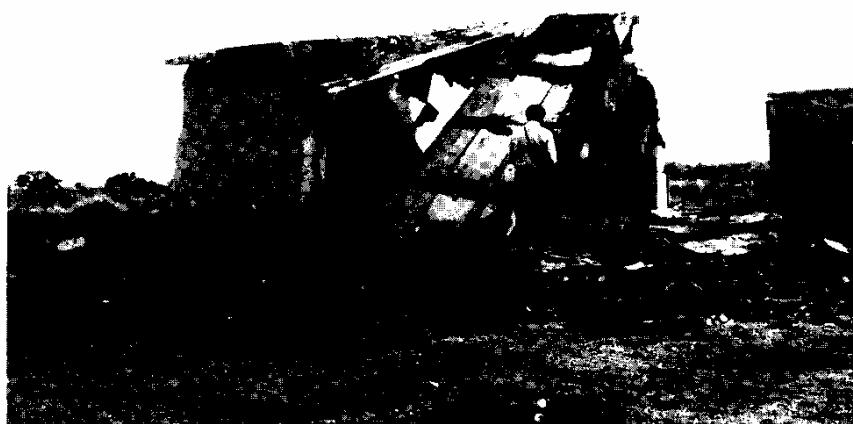
masonry with cement mortar. The roof consisted of lightweight pre-cast planks 4 m long and 12 cm thick spanning from a light steel truss at the center of the building to the masonry walls. The planks were held together at the line of the truss by steel strips tacked with an epoxy material. No diaphragm action was possible due to the lack of proper connections between the walls and the panels, between the panels and the truss, and between the panels themselves. The roof panels collapsed, demonstrating, yet again, the seismic vulnerability of precast panels without adequate connections.

Figure 6 - A brick masonry school building in Rajegaon collapsed. The roof of precast panels lacked adequate connections.

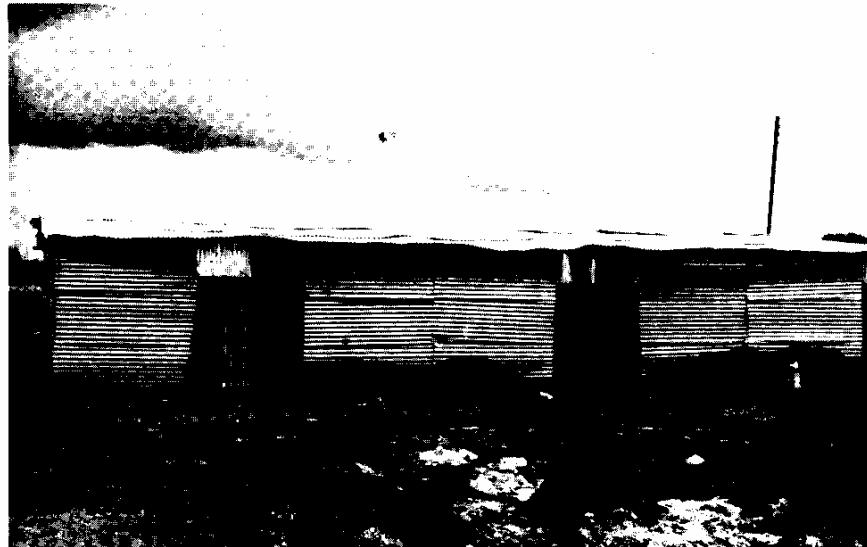
Figure 10 - Temporary shelters of galvanized iron sheet were rapidly erected. Each provides shelter for five families.

Temporary Shelter: Immediate shelter was provided by erecting temporary galvanized iron sheet houses. Each shelter consisted of five units of about 15 m² area each; each affected family was offered one such unit. Common toilets and hand-operated bore wells were provided. Some families chose to take tents and tin sheets instead, and made their own shelters.
