## Learning from Earthquakes

### The Chamoli, India, Earthquake of March 29, 1999

#### Introduction

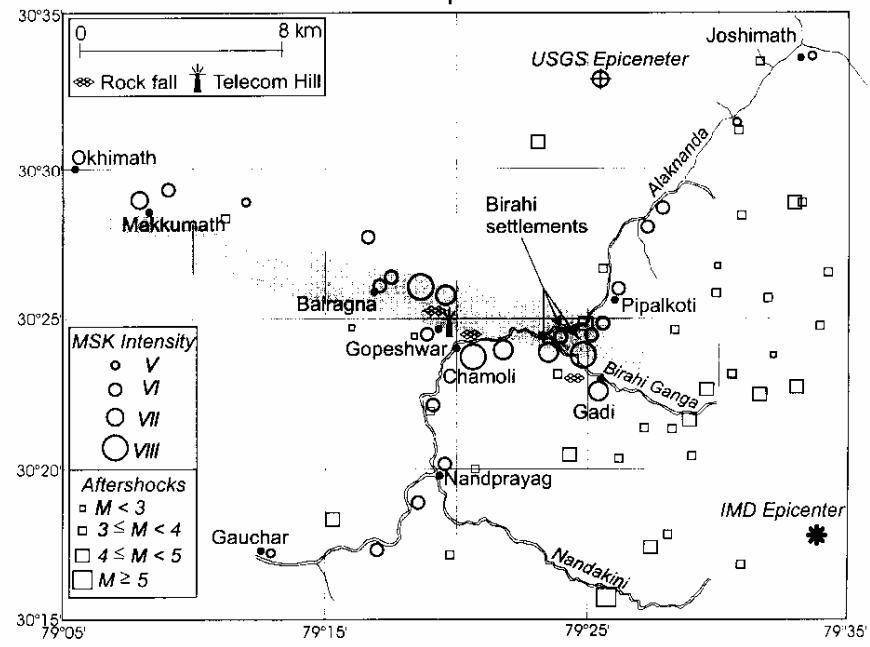
Figure 4: Intensity variation during the main shock and location of aftershocks in the affected area. Shaded portion shows the trend of the fault from the fault-plane solution, which is consistent with the damage distribution.

Figure 4 shows the intensity of shaking at some locations. Intensity showed rather abrupt changes from one location to another, because of site effects on river terraces composed of alluvial deposits of sand and boulders. For instance, the right bank of the Birahi Ganga River has two settlements: Upper and Lower Birahi, about 1 km apart. The intensity of shaking was VIII at Upper Birahi on the river terrace at a higher elevation, whereas it was VI at Lower Birahi on hard rock. A forest department checkpost just across the river from Lower Birahi also showed higher intensity (VII) due to its location on the river terrace. The intensity at Lower and Upper Chamoli was VIII, but at Gopeshwar, located 2 km away, it was V. While Chamoli is located on the river terrace, Gopeshwar is at a

higher elevation on the hill slopes. The intensity VII observed at Makkumath, located on a river terrace about 20 km from the epicenter, is possibly another example of site amplification due to alluvial cover.
